GLARE teardowns from the MegaLiner Barrel (MLB) fatigue test

NLR-TP-2009-068

February 2009

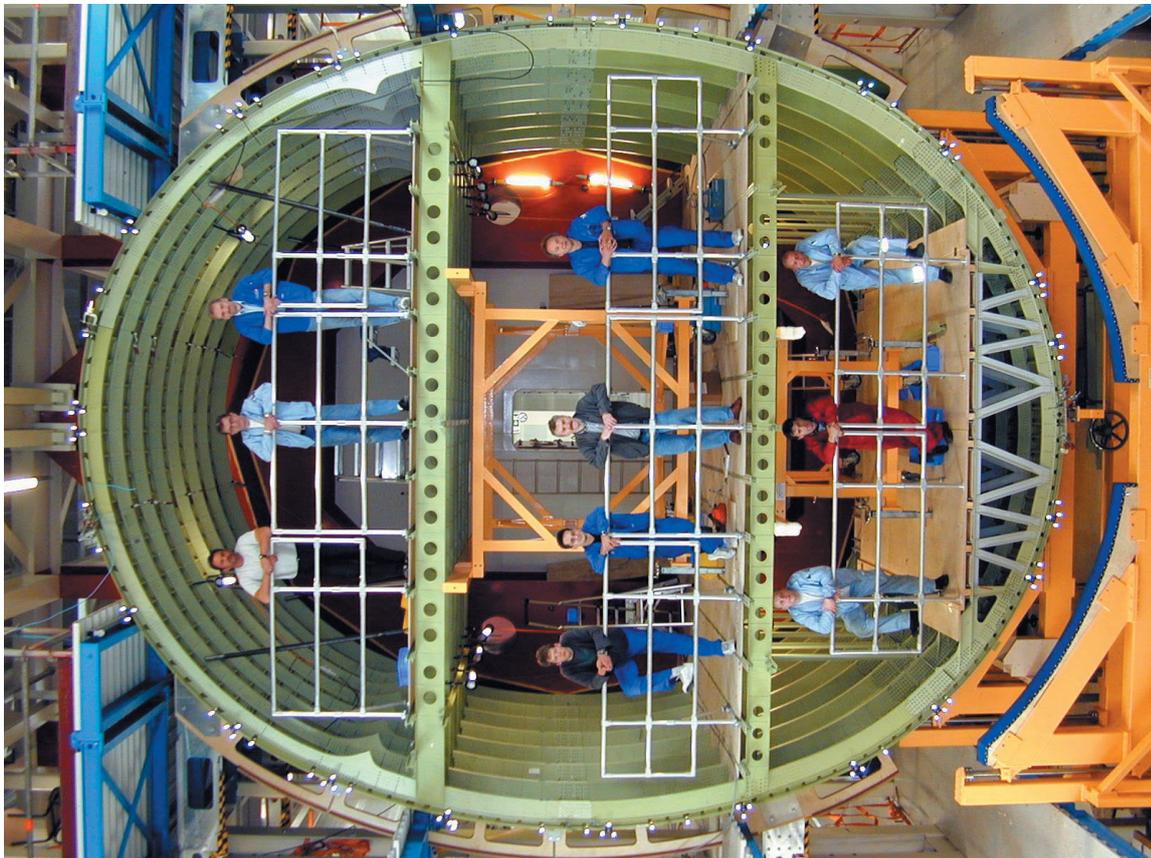
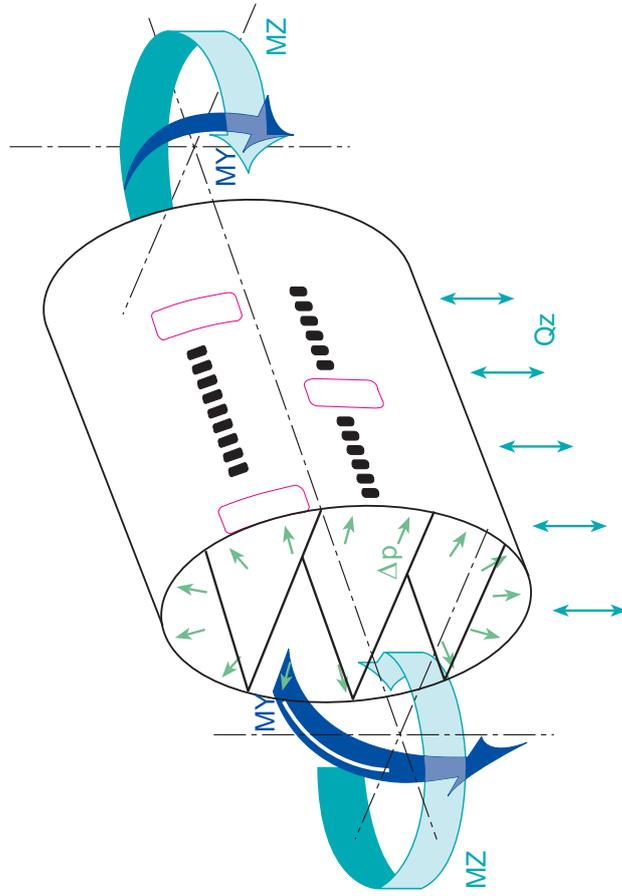
Figure 1 The MLB configuration and general loading conditions

Figure 1 shows the MLB in the test hall in Hamburg, and the general loading conditions applied in the test rig. These were pressurization cycles combined with longitudinal and transverse bending and ground loads. Figure 2 shows a schematic of the MLB with key-codes of its construction and the GLARE locations investigated by the NLR. F4 is the window area, F6 is the stringer coupling area, and F7 is the passenger door beam area. The colour-shading codes refer to the GLARE and aluminium alloy skin materials. The GLARE, 2024 and 2524 panels were assembled with mechanical fasteners. The 6013 and 6056 panels were welded.

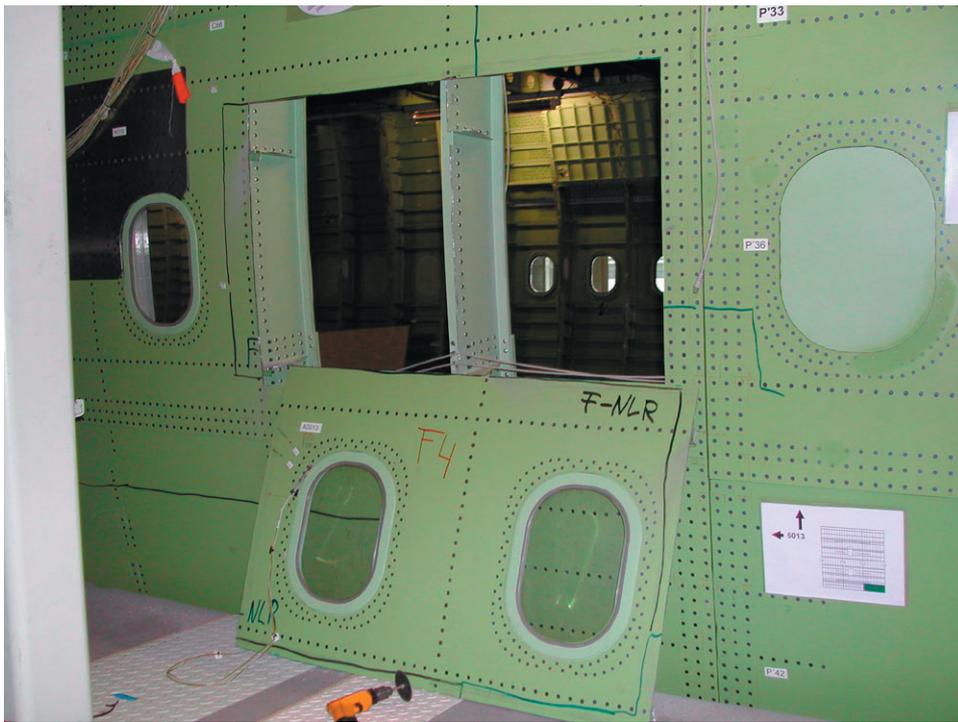
Figure 3 The F4 GLARE window area just after its removal from the MLB

Figure 3 shows the F4 GLARE window area just after its removal from the MLB. There is a circumferential butt joint (C64, see figure 2) just to the right of the removed area. The basic structure of the window area was a GLARE 3-7/6-0.3/0.4 countersunk skin fastened to die forged 7175-T73 aluminium window frames by 4.76 mm press fit Hi-Loks. The GLARE code means seven 2024-T3 aluminium layers 0.3 mm or 0.4 mm thick and interleaved with six glass fibre layers 0.25 mm thick; the outer two aluminium layers were 0.4 mm thick.
