Patch repair of cracks in the upper longeron of an F-16 aircraft of the Royal Netherlands Air Force (RNLAf)

W.G.J. 't Hart and J.A.M. Boogers

This report is based on a presentation held at ICAS, Toronto, Canada,
8-13 September 2002.

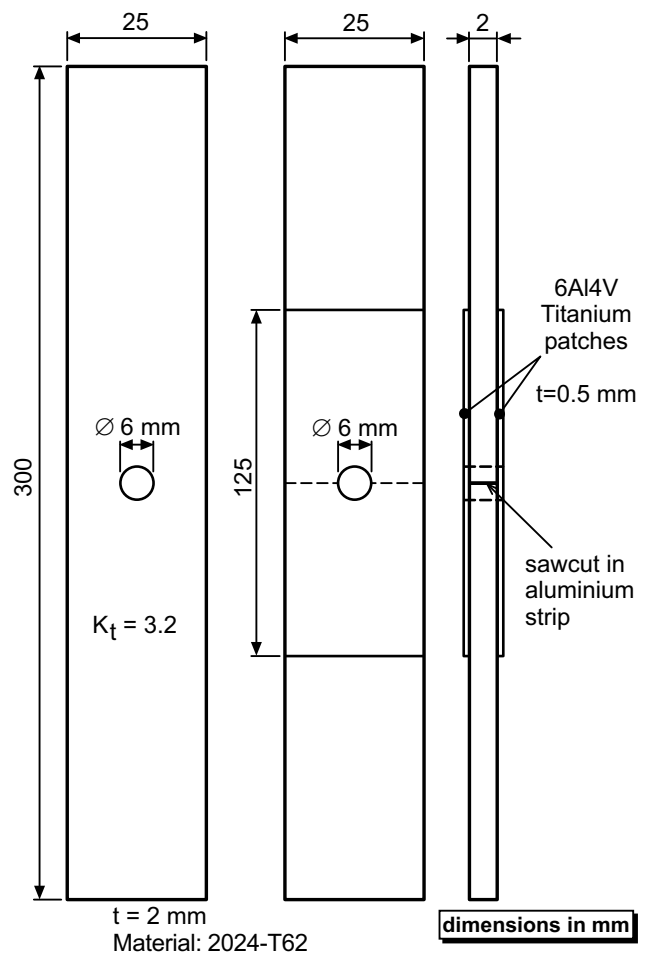
In order to assess the performance of the patch repair, limited fatigue tests were performed on notched 25 mm wide aluminium strips with and without a patch repair, figure 5. Two open hole specimens and two patch repair specimens were prepared. A fastener of 6 mm in diameter was installed in the central hole of the repaired coupon specimen. The fastener was torqued at 3 Nm, simulating the panel attachment to the longeron flange. However, load transfer occurs exclusively through the bonded Titanium patches.

Fig. 5 Fatigue specimens for flight simulation fatigue testing

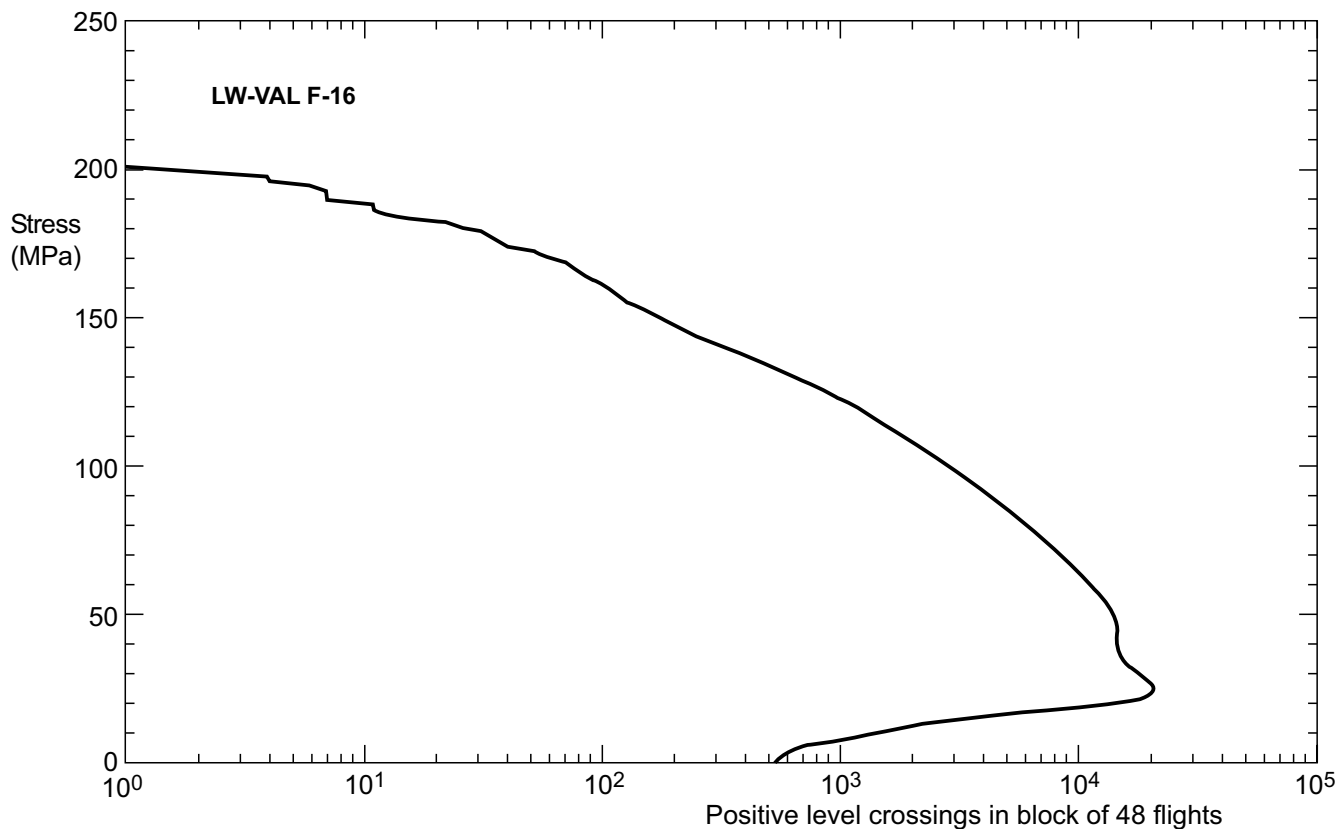
However, no directly usable sequence for the fatigue testing machine was available. Measurements on F-16 aircraft of the RNLAf showed a more or less similar shape of the forward fuselage and the wing root bending spectrum. Therefore the LW-VAL F-16 load sequence was selected, this being representative for the wing root bending moment for a severe EPAF** usage, figure 6. For ease of testing the negative stress levels in the sequence were set to zero. To obtain a reasonable testing time for the specimens with the central hole, the fatigue tests were executed at 130 % of the LW-VAL load sequence. This means that the maximum gross stress in the specimens was 268.5 MPa. According to GD-16 PR8150 [4] the maximum spectrum stress for longeron 16B1111 is 196.77 MPa (28.11 ksi).

Fig. 6 Stress and cumulative level crossings of 100%-LW-VAL F-16

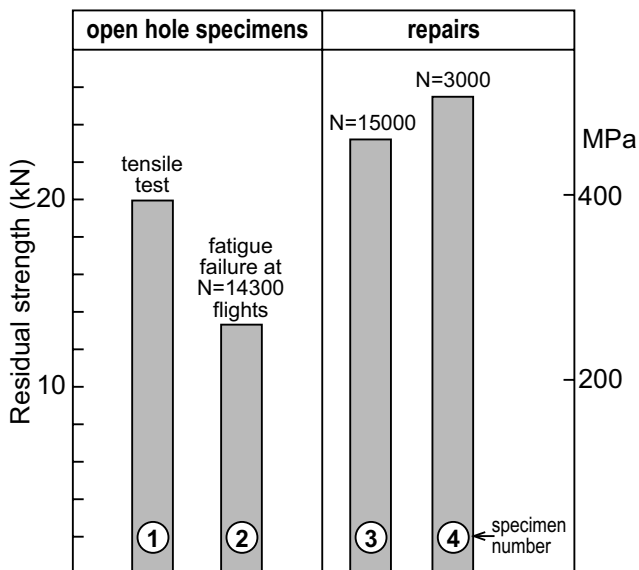
Figure 7 gives the test results. The static failure load of the undamaged open hole specimen was 19.9 kN, specimen 1. Fatigue testing at 130 % LW-VAL resulted in a life of 14300 flights, specimen 2. Specimen 3 demonstrated that the repair survived 15000 flights after which a residual strength of 23.1 kN was obtained. NDI before residual strength testing showed local delamination at the edges of the titanium patches. Specimen 4 did not show signs of debonding after testing for 3000 flights. The residual strength was 25.3 kN. Figure 8 shows the failed repair specimens. Both specimens showed tensile failure of the

Fig. 7 Test results of experimental programme
