*Society of Experimental Test Pilots*  
*49th European Symposium ~ Bristol, England*  
*11-15 Jul 2017*

## **Stopping performance flight test on a flooded runway**

### **Introduction**

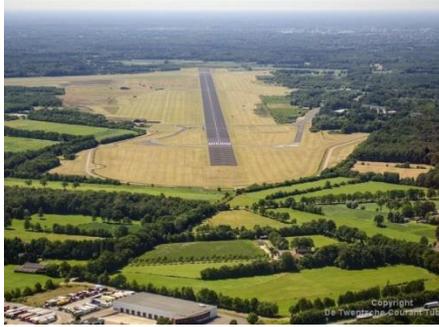
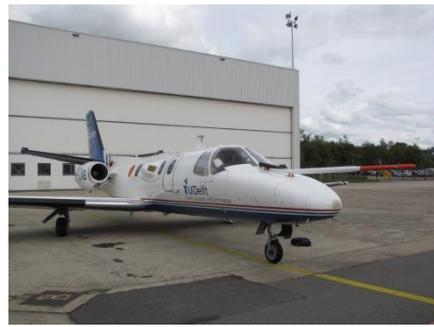
Figure 1 Aerial view of the airport of Twente and NLR/TUD research aircraft PH-LAB

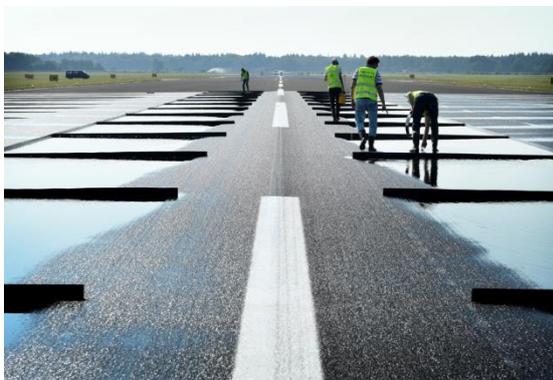
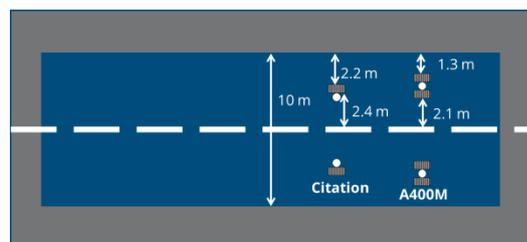
Figure 2 NLR water pond facilities at EHTW

In Europe only a small number of sites are suitable for tests at flooded runways. However their availability but did not fit our schedule (Cranfield UK, Istres France). The formal air force base Twente (EHTW), the Netherlands, turned out to be an option, but it lacked water pond facilities. NLR decided to construct a water pond at this airport. The pond was build using flexible re-enforced rubber strips as dikes. The longitudinal slope requires that several rubber cross dams had to be constructed to get reasonable consistent water levels in the water pond. These cross dams were placed every 7.7 m. The overall length of the water pond was 100 m. The nose wheel does not run in the water as only brake performance was assessed. The water pond is shown in Figure 2. The average water depth at the main wheel track was aimed at 15 mm. The runway 05/23 has a (cross section) camber of around 1.5 %, with some lower values near the centreline. The runway slope in longitudinal direction was 0.2 %. As a result in each section the water depth varied both in longitudinal and lateral direction. In the figure 2 the location of the main wheels, during pond passage, are indicated. A typical water depth distribution is given in figure 3.

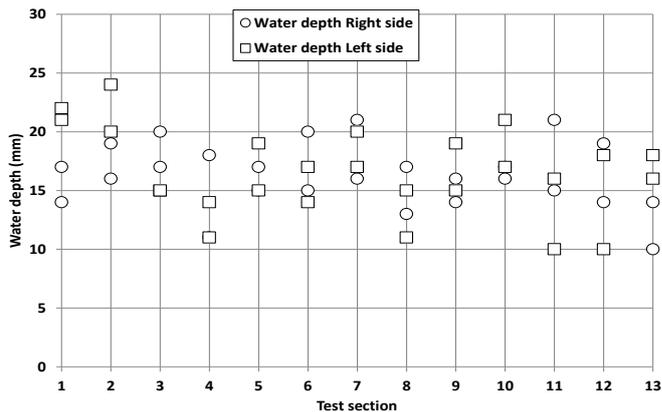
Figure 3 Typical water depth per test section

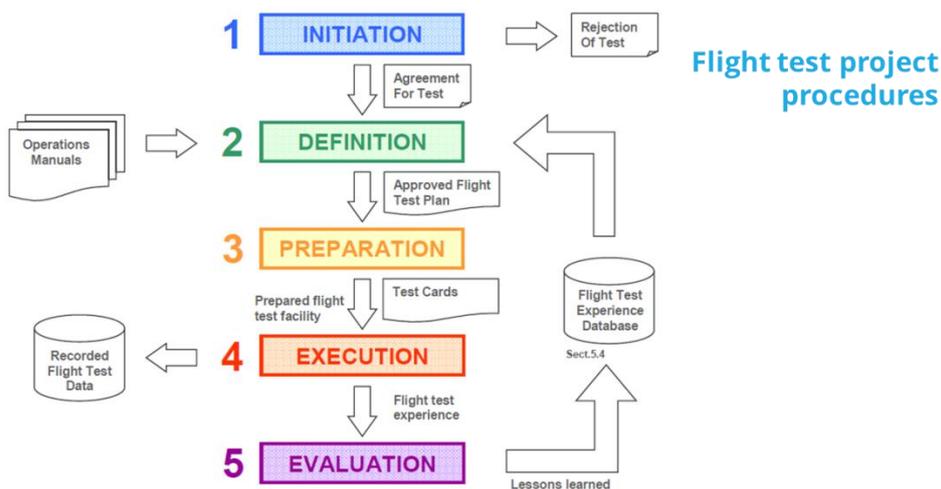
The NLR/TUD flight test organisation has the following flight test process in place.

In phase 1, the flight test process is initiated by the Request for Test (RFT). This is the handshake between the NLR project and the NLR/TUD flight test organisation. All known aspects of a requested flight test project should be identified and discussed, i.e. subjected to a preliminary assessment, including a preliminary risk assessment. Phase 1 is finalized by a Decision for Test.

Phase 2 contained the generation of a Flight Test Plan. In this plan, the test program is described and planned in detail. The flight test could be summarized as follows:

Phase 3, the preparation phase resulted in the aircraft, equipment and crew ready for the test flight and Test Cards generated.

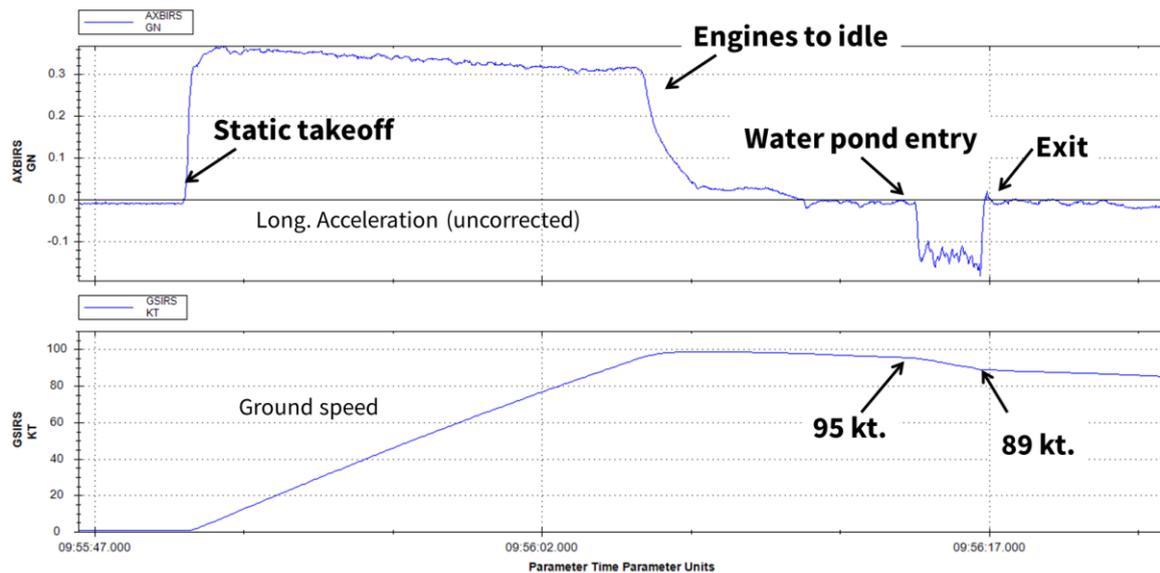
Figure 4: Longitudinal acceleration and ground speed time-history plot for a typical test run (ref. 1).

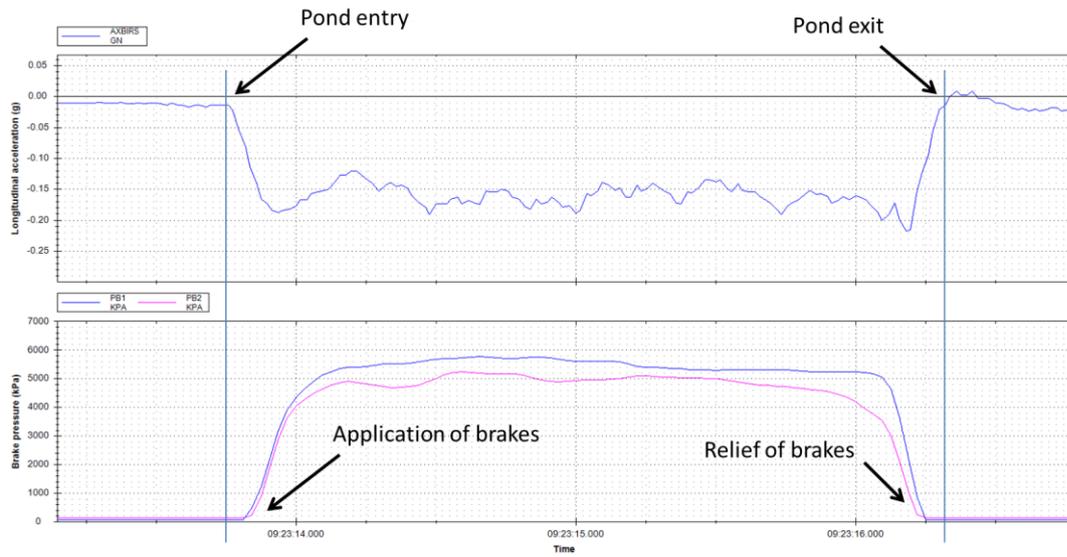
Figure 5: Time-history plot of longitudinal acceleration and brake pressure (ground speed between 85-78 kts.) (ref. 1).
