NLR-TP-2013-586

## **In-flight lightning damage assessment system (ILDAS): Further in-flight verification, with multi- sensor configuration**

This report is based on a presentation held at the International Conference on Lightning and Static Electricity (ICOLSE), Seattle, 18-20 September 2013.

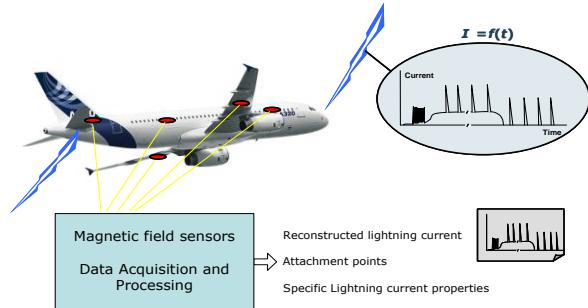
Figure 1 – Reconstruction of the lightning channel current

ILDAS can determine the electrical current waveform of the lightning channel and the points of attachment on the aircraft. Synchronous measurements of the magnetic field are performed on various parts of the aircraft (in particular the cabin, the wings and the tailplane) using a dedicated data acquisition system. The resulting data from multiple sensors are subsequently processed by a numerical toolkit called EM toolkit, which employs an inverse method based on a detailed aircraft electromagnetic model to determine the lightning attachment points and to reconstruct the lightning current waveform.

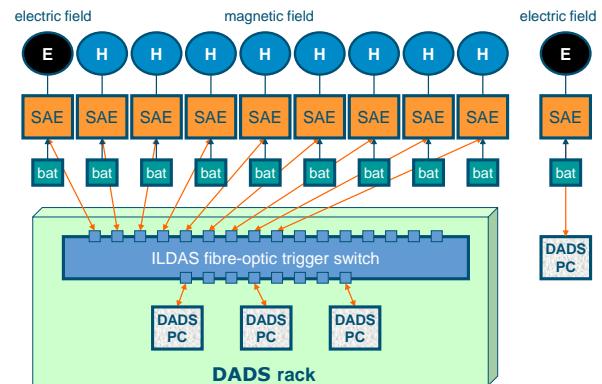
Figure 2 – ILDAS architecture

The ILDAS system is designed for triggered measurement of lightning-induced fields. Eight magnetic-field and one electric-field sensor assembly are placed at various locations in the cabin, with their sensors mounted on the inside of a cabin window, see Figure 2. Custom battery-powered sensor assembly electronics units (SAE) perform sensor data acquisition and local temporary recording in one of the two internal memory buffers inside each SAE. A fibre-optic Ethernet link connects each sensor assembly to a centrally mounted data accumulation and data storage component (DADS), consisting of a custom fibre-optic Ethernet switch and Linux-based laptop computers for system control and

Additionally, for this campaign a second electric-field sensor was installed, independent of the ILDAS system (see right-hand side of Figure 2). It performed continuous measurements at a reduced sample rate of  $2.5 \mu\text{s}$  for the full duration of the flight. It was installed as a backup provision for evaluation of the electric-field trigger algorithm.

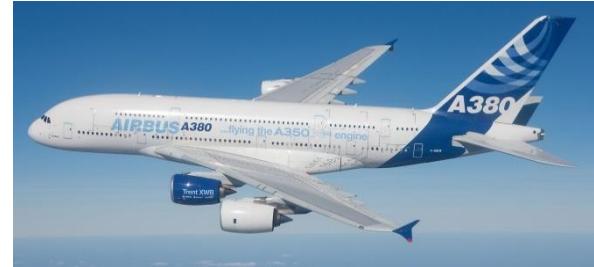
The system was installed on board an A380 flight test aircraft used as a flying test bed for the A350 XWB engine, see Figure 4. Part of the engine's certification was a flight test campaign under icing conditions. During such campaigns

test aircraft are typically struck by lightning multiple times per flight. At the inboard left position the regular A380 engine is replaced by the A350 XWB engine under test.

*Figure 4 – ILDAS equipment was installed on the A380 flying test bed for the A350 XWB engine during the engine's icing certification flight tests*

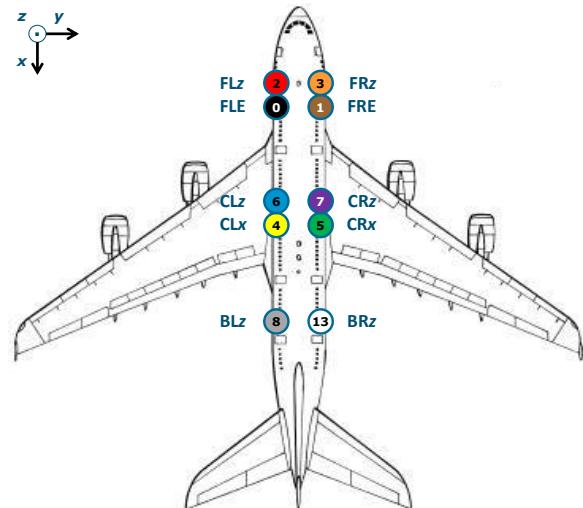
ILDAS equipment was installed on the upper deck. The location of the sensors in the cabin is shown in Figure 5. The electric-field sensors, FLE and FRE, are placed in the front of the aircraft. The other sensors are magnetic-field sensors, generally measuring the  $H$  field component in the  $z$  axis direction for current flowing from nose to tail. The CLx and CRx sensors measure in the  $x$  axis direction, for current flowing from wing to wing.

*Figure 5 – ILDAS sensor configuration for A380 flight tests*

The magnetic-field of the stroke with the largest amplitude that was recorded during the campaign is shown in Figure 11 and Figure 12. Waveform colours are matched with the sensor colours used in the aircraft installation diagram, Figure 5. The representation of the sensor signal polarities was chosen so that positive signals in the graph indicate fuselage current in the positive  $x$  axis direction, i.e. nose to tail. For the two sensors with alternative orientation, CLx and CRx, the signals are shown positive for currents in the positive  $y$  axis direction, i.e. from left to right wing in an aircraft top view.

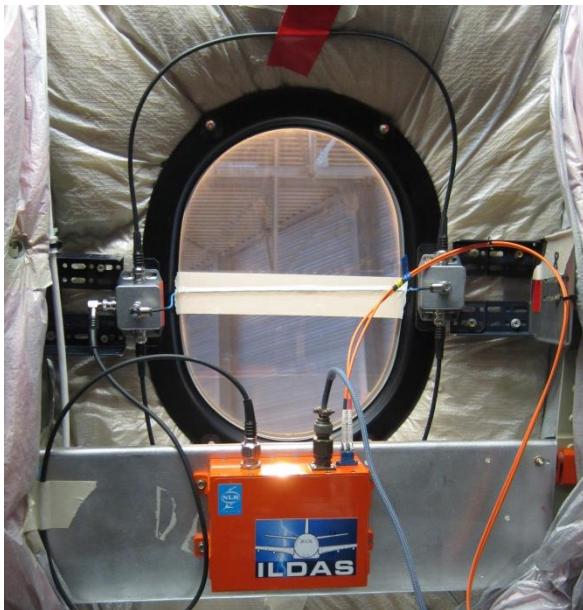
Figure 6 shows the magnetic-field sensor installation in the flight test aircraft's cabin, in this case the FLz sensor. The magnetic field window sensor consists of two boxes mounted to either side of the window with two interconnecting cables going around the window top and bottom,

and a horizontally mounted cross wire that was taped to the inner pane of the double-pane cabin window (in the test aircraft, the windows are not fitted with a third, thin window panel as in normal airline use). The orange unit is the SAE, with connections, from left to right, for the analogue sensor signal, (battery) power input, and fibre-optic digital communication network.

*Figure 6 – Installation of the magnetic-field window sensor*

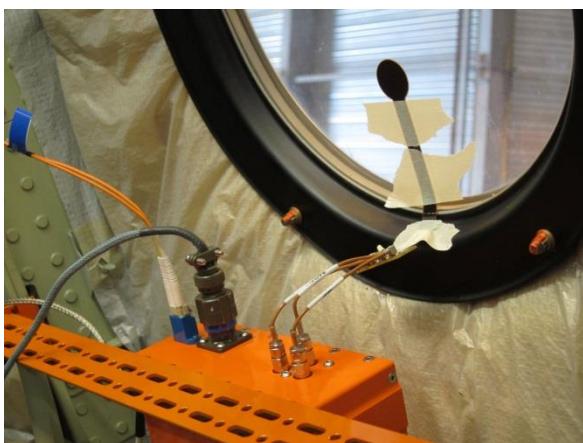
Figure 7 shows one of the two electric-field sensor installations (FRE sensor). The sensor is taped to the window at a fixed distance from the bottom rim of the cabin window. Connections comprise the E1 and E2 channels and a test electrode.

*Figure 7 – Installation of the electric-field window sensor*

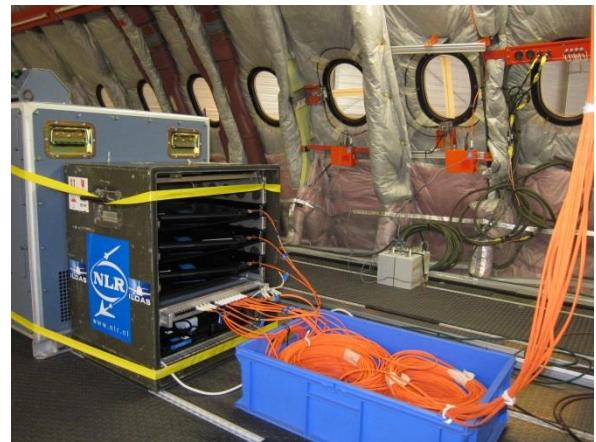
Figure 8 shows the DADS equipment, three laptop PCs, fibre-optic switch and support equipment mounted in a vibration-damping cabinet, provisionally installed in the aircraft cabin. In the back the centre-right window sensor installations can be seen with their horizontal (CRz) and vertical (CRx) cross wire on the cabin window.

*Figure 8 – Installation of the DADS equipment cabinet, and two window sensor installations (horizontal and vertical) in the background*

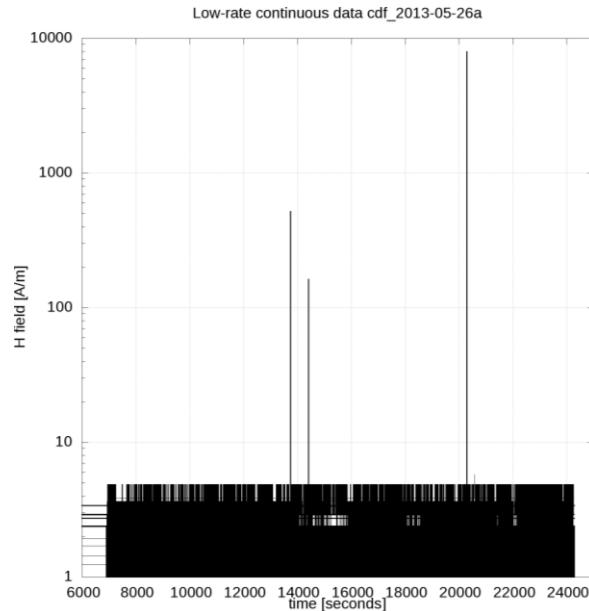
Figure 9 shows data from the continuous measurement channels, which provides low-rate statistical summary of  $H$  field data suitable for waveform inspection at large timescales. The x axis is time in seconds; the graph spans the

complete flight recording duration, starting at  $t = 6900$  s and lasting for 4 h 48 min. The y axis contains the recorded field extrema for all eight  $H$  sensors in A/m on a logarithmic scale. Three spikes denote the three lightning events during the flight. The period between 0 s and 6900 s covers a time when the trigger switch, which acts as the system's time reference, was switched on but the SAEs were not switched on yet.

Figure 9 –  $H$  field levels recorded during the complete flight, displayed on a log scale

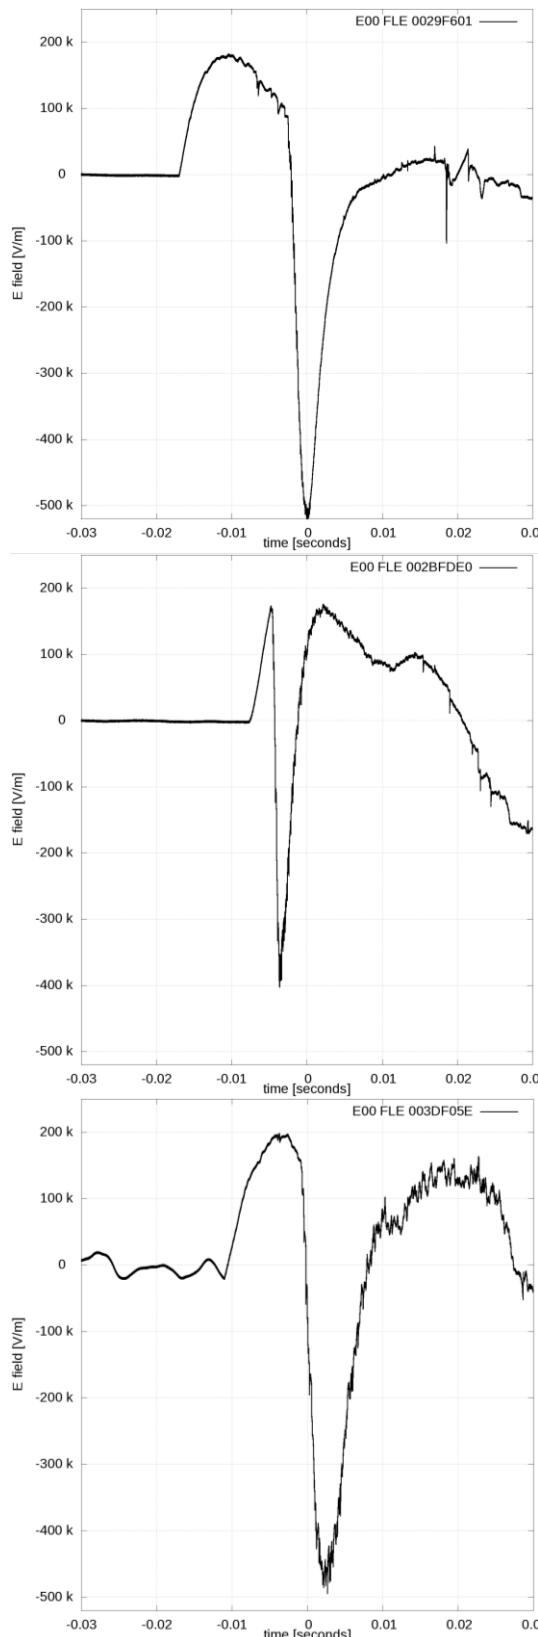
The electric-field data for the three strikes (Figure 10) show the characteristic waveform that is used for trigger purposes. The electric field will rise to over 100 kV/m relatively slowly and then decay fast. This pattern is associated with positive leader development starting from the aircraft. The x axis is in seconds, with  $t = 0$  being the moment that the ILDAS system was synchronously triggered. The  $E$  field bandwidth was extended at the low-frequency side from 100 Hz to 10 Hz as a result of the initial engineering flight tests in 2011. With the extended bandwidth, the  $E$  waveforms are in accordance with expectations, and are better suited to trigger on.

Figure 10 –  $E$  field waveforms for the three strikes on 26 May, showing a characteristic waveform

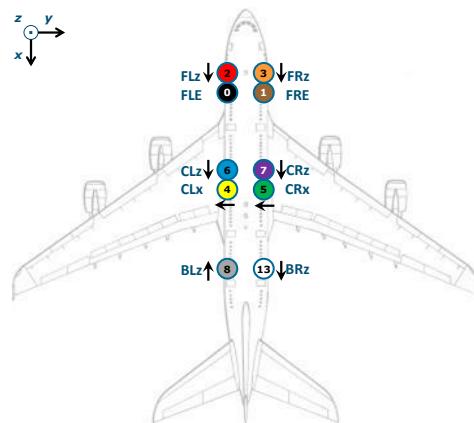
Figure 13 shows the direction of the local fuselage currents for the strike. Based on simulation results with the aircraft EM model, this pattern is indicative of a nose to left wing scenario. At this time it cannot be determined in detail which part of the left wing was involved, e.g. the left wing tip or one of the engines.

Figure 13 – Direction of surface currents at the sensor positions

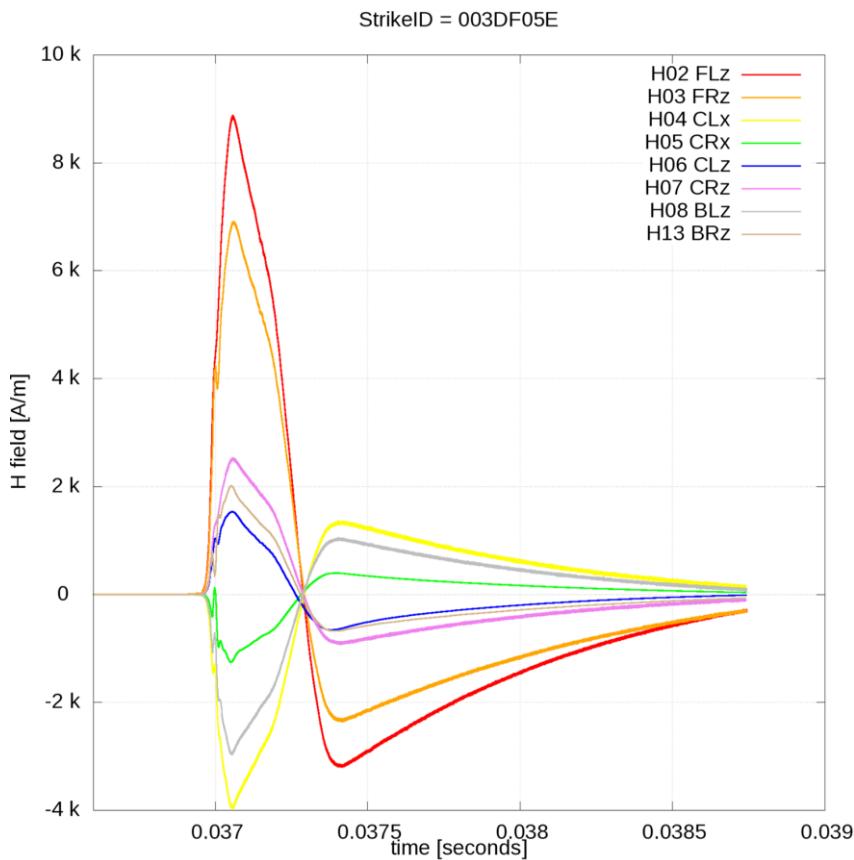
**Figure 11**  
Magnetic-field data from a synchronous lightning recording performed by all eight sensors

Here  $r$  is the average radius of the A380 fuselage of 3.9 m and  $H_0$  is the average of the FLz and FRz measured fields. The estimation results in a peak aircraft current of 190 kA, representing a severe strike.

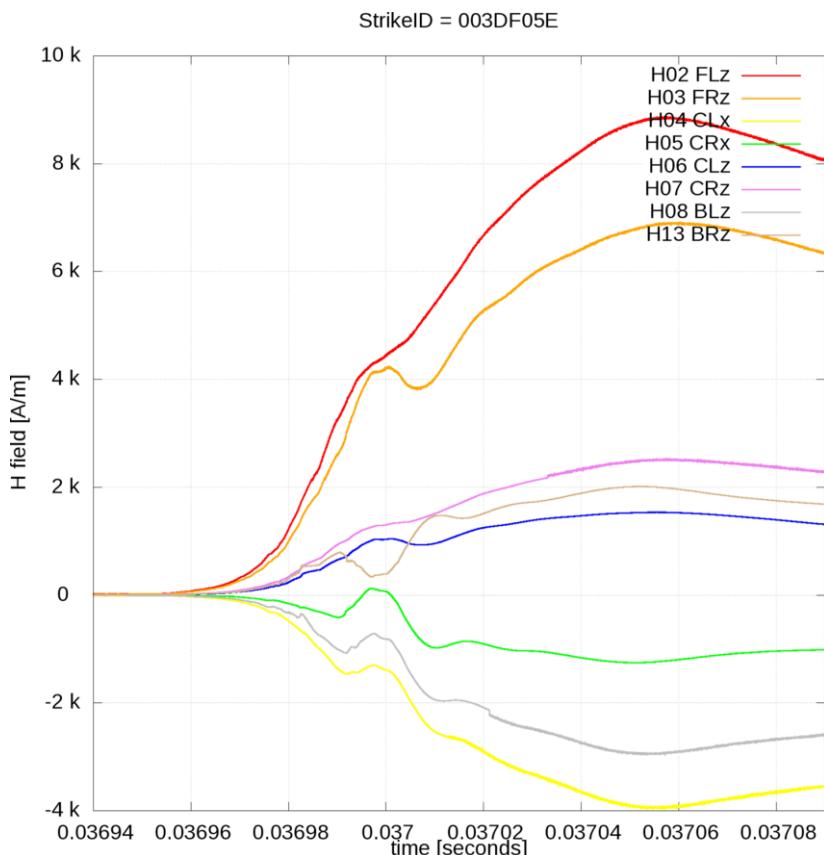
**Figure 12**  
A zoomed-in version of the figure above, showing detail of the rising edge of the stroke

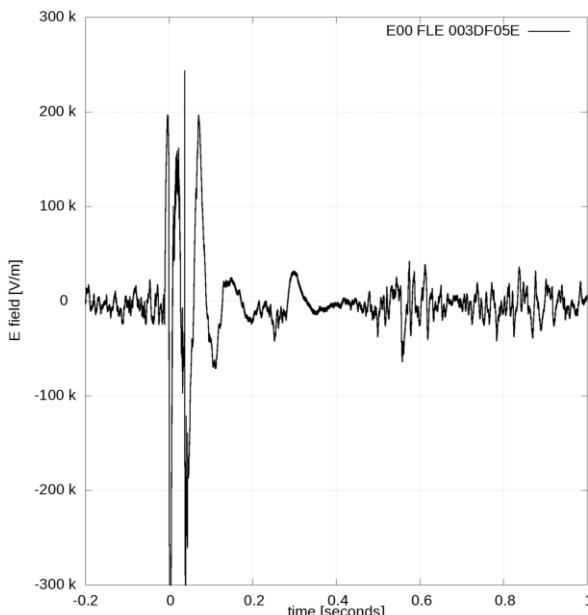
Figure 14 – Full-duration (1.2 s) recording of a genuine trigger

An important observation from the flight tests was that there were numerous false triggers, i.e. the system acted as if a lightning strike had occurred to the aircraft, but analysis after the flight showed that no surface current signals other than noise were recorded. Figure 14 shows the complete recording (1.2 s duration) of the electric-field for a genuine lightning detection. The characteristic electric-field waveform, which was shown in more detail in Figure 10, represents a significant signal. Figure 15 shows the electric-field of a false trigger using the same scaling. The waveforms for genuine and false triggers show remarkable differences, giving confidence that improvement of the trigger algorithm should be achievable; however this requires detailed analysis which was only in a very early stage at the time of writing.

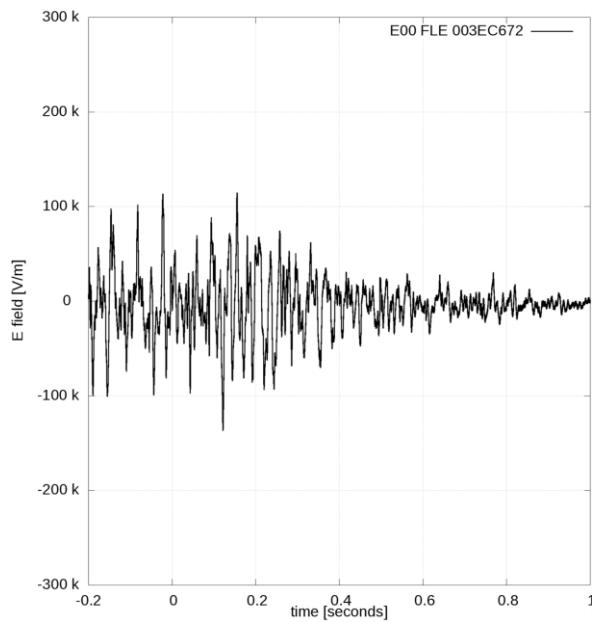
Figure 15 – Full-duration (1.2 s) recording of a false trigger

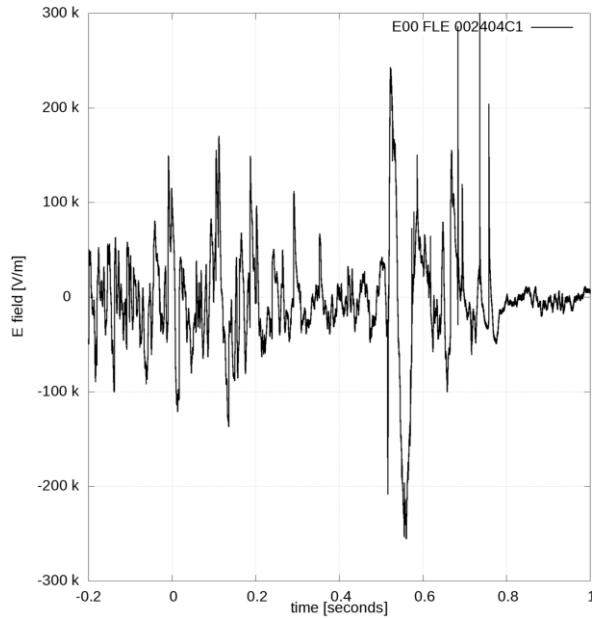
Figure 16 shows a different recording with a remarkable coincidence. The system was falsely triggered, shown as  $t = 0$  in the graph, but within the 1 s recording period after this trigger, a true lightning attachment occurs at  $t = 0.52$  s and a strike takes place. The magnetic-field data (not shown) confirms this: there is only regular noise up to the true attachment point, followed by multiple strokes occurring between  $t = 0.53$  s and  $t = 0.76$  s.

Figure 16 – Full-duration (1.2 s) recording of a false trigger which by coincidence captured a lightning strike later in the recording.

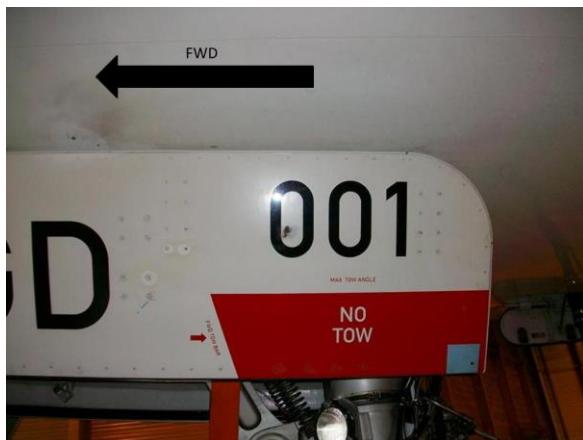
Figure 17 – The left nose landing gear door with minor damage in the '001' lettering

A first aircraft inspection after the 26 May flight revealed relatively minor damage on the doors of the nose landing gear (see Figure 17 and Figure 18), right-wing inboard engine nacelle and on two right-wing flap track fairings. Lower-intensity strikes on other days seem to have led to larger damage spots after a first overview.

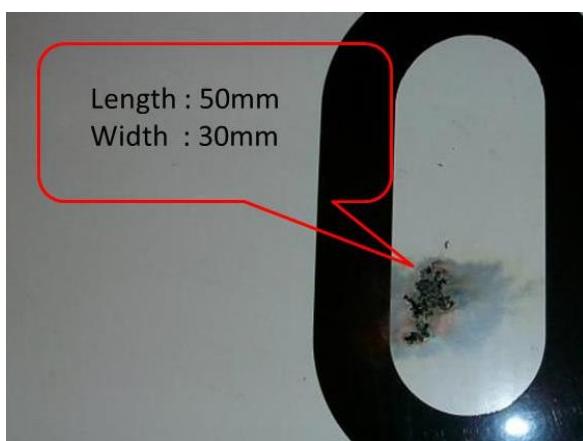
Figure 18 – Detailed view of nose landing gear damage
