Experimental Evaluation of Vibration-Based Damage Identification Methods on a Composite Aircraft Structure with Internally-Mounted Piezodiaphragm Sensors

NLR-TP-2015-196 - July 2015

Auteur(s)
J.S. Hwang
R. Loendersloot
T. Tinga

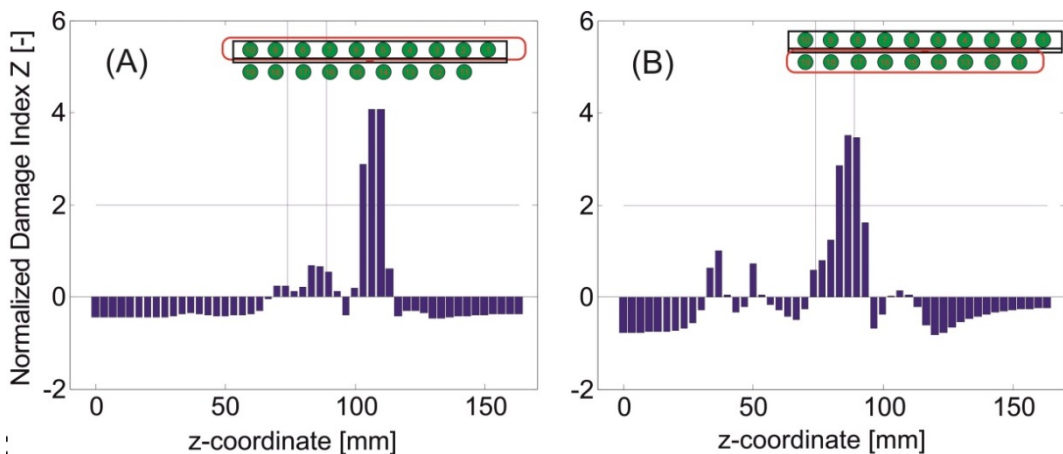
Figure 5. The normalized MSE damage indicators calculated from the dynamic measurements on row A and B. The damage has occurred between 79 and 94 mm (two vertical lines). The green dots indicate the piezodiaphragms used to calculate the normalized DI, the red curve encloses the sensors used to create the DI plot

Figure 5 shows the MSE-DI calculated with the measurements from piezo-diaphragm 1 to 10 (attached to the stringer, called row A) and 11 to 19 (attached to the skin, called row B). This DI

shows that damage, expected to be located around $z = 80\text{mm}$, is detected successfully. However, peak with significantly higher Z on the row A (Figure 5B) is present which deviates from the stringer failure by approximately 30 mm. On the other hand, the DI calculated with the measurements from the row B indicates the damage location correctly. This shows that the placement of sensor array influence the performance of the SHM strategy significantly. A possible explanation for this biased results can be found in the stiffness difference in the structure. Row A and B experience different stiffness from the structure, resulting in less sensitive measurements in row A compared to B. This could have been avoided if the distance between row A and B was set larger such that the stiffness in both rows are (more or less) equal. Additionally, the global mode shapes could be captured better in less stiff area, where the vibration amplitude can be expected to be higher.
