NLR-TP-2005-478

Structural analysis and optimisation of an all-composite damage tolerant wingbox

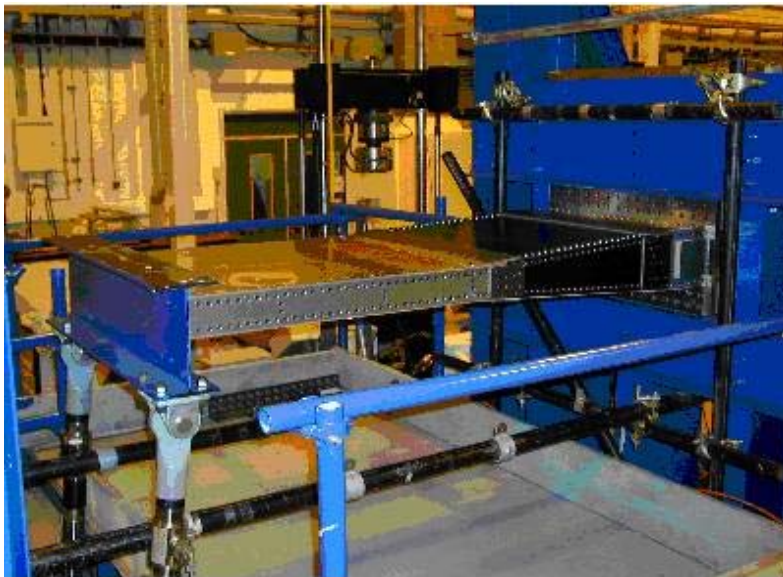
Fig. 2 Modular wingbox under test at QinetiQ

The actual panel geometry for all the test specimens is a panel 710 mm wide by 600 mm in length, figure 1 (DAM1 configuration). The extra length is only used for assembly in modular wingbox testing facility at QinetiQ, figure 2. This uses a metal frame to support the composite test panels and permits novel materials and structural elements to be tested within a structural context, [2].

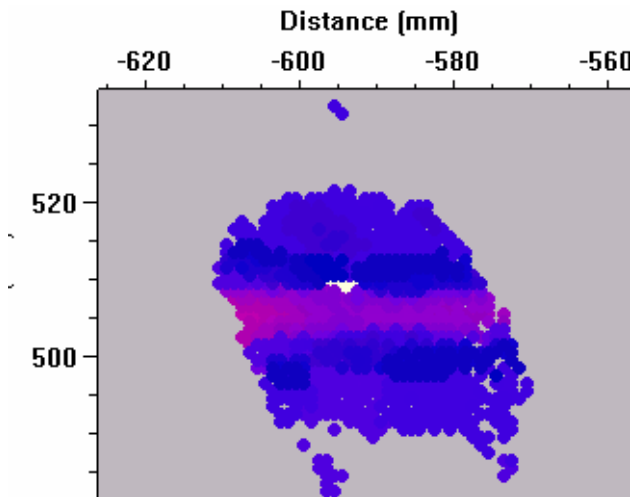
Fig. 7 ANDSCAN results after damage resistant impact level applied

The wingbox was then subjected to localised low velocity impact. See figure 6 for the impact locations. An impact energy threat level of 22.8J, was applied to the wing skin. The threat level used was the maximum that the structure was predicted to withstand before damage was caused, which is called the damage resistance of the structure at the particular location. The size of damage caused at this threat level of 22.8J was estimated by ANDSCAN to be 3.8 mm across.

This damage is associated with a surface chip and can be considered as no damage or the limit of damage resistance, figure 7.

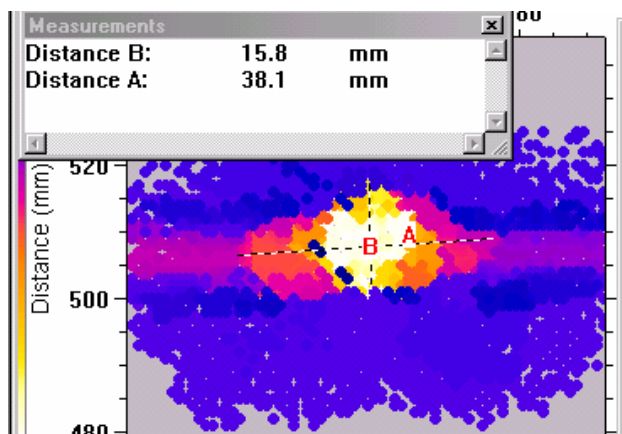
Fig. 8 ANDSCAN results after 35J impact threat applied

Subsequent impacting at the same location with a threat level of 35J resulted in the damage propagating along the centre line between the two z-pinned areas (Fig. 8). This growth was encouraged by a small change in section thickness as a result of the manufacturing process. An impact of threat level 35J was then centred within a bay which contained no z-pin reinforcements and was used as a comparison to the response of the previous impact site. The predicted damage resistance of the second impact location was 31.4J. The higher value for the damage resistance is caused by the more compliant response of the structure for an impact in the middle of a bay compared to an impact in the proximity of a rib as was the case for the previous impact site. Another contribution to the less compliant response of the first impact could be attributed to the application of z-pins in the bay; these would increase the stiffness of the skin in
