Multi-disciplinary installation of the Eagle's Eye

NLR was tasked by the Dutch Ministry of Defense to answer the question, whether Unmanned Aerial Vehicles [UAV] can fly safely in European uncontrolled airspace without risking collision with other aircraft. The question was laid down in a National Technology Project, called 'OUTCAST' (Operations of (military) UAV – Transition to Civil Air Space and Traffic environments), which has been running within NLR since 2004. Phase 2 of OUTCAST consisted of 'Demonstrator Development' [Ref. 1] which was accomplished in 2007. The Dutch National Aerospace Laboratory [NLR] had designed a non-scarring construction for installation of a heavy camera in the nose of its research aircraft, a Cessna Citation 2. Aspects like structural strength, metal fatigue and air loads were considered in conformity with Federal Aviation Regulations [FAR] part 25. The European Aviation Safety Agency [EASA] Part-145 certified NLR Research

NLR-TP-2008-812

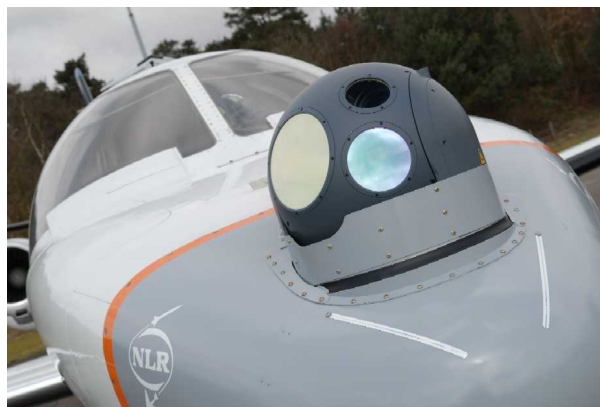
Fig. 1 Final and certified situation of camera installed on Cessna Citation 2

NLR RATO defined the deliverable as follows: ‘The end product as delivered is a certified and airworthy aircraft, being equipped with the specific EO/IR Camera, camera control systems and the UAV pilot ground station, which is located in the aircraft cabin for convenience.’

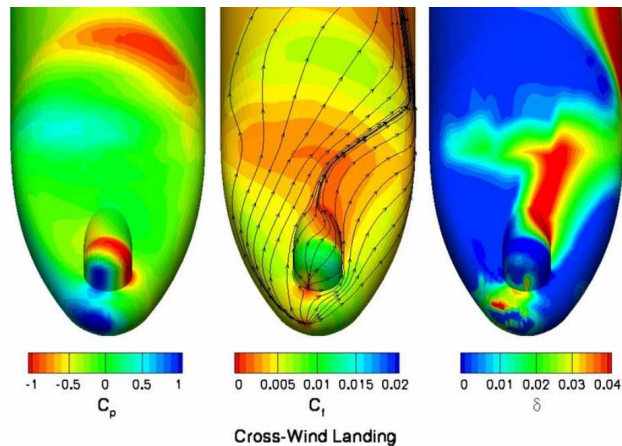
Fig. 2 Results of Surface Pressure Coefficient (C_p), Skin Friction Coefficient (C_f) and Boundary Layer Momentum-loss Thickness (δ) for the Cross Wind landing configuration.

1. Stall ($V = 91$ kCAS, $\alpha = 12^\circ$, $\beta = 0^\circ$)
2. Cross-wind landing ($V = 118$ kCAS, $\alpha = 6^\circ$, $\beta = 16^\circ$)
3. High Speed flight ($V = 262$ kCAS, $\alpha = -0.3^\circ$, $\beta = 0^\circ$)
4. High Speed flight with sideslip ($V = 262$ kCAS, $\alpha = -0.4^\circ$, $\beta = 10^\circ$)
5. Dive ($V = 393$ kCAS, $\alpha = -0.8^\circ$, $\beta = 0^\circ$)

The CFD analysis revealed the following: it seemed possible to install the camera with fairing on the proposed position. The fairing should be able to avoid large scale flow separation downstream from the camera. Camera vibration will be reduced by use of the fairing. No indications were found concerning negative impact on aircraft handling quality or on airspeed- and altitude indication. Based on this conclusion, it was stated that camera and fairing installation for flight test execution is acceptable. Flight test execution is essential to verify in practice the CFD analysis.

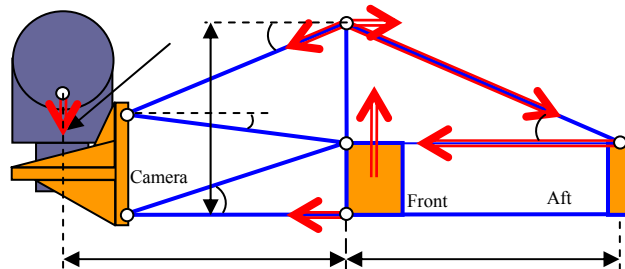
Fig. 3 Overview of load and forces

- Vertical gust load
- Load in longitudinal direction
- Load in lateral direction
- Vertical gust load (see Fig. 3)

Using the design dimensions and the vertical gust condition as shown in Table 1, being 4874 N, gave a load of 7052.2 N on tube DA. Because of the interconnection between the forward and aft brackets via the upper rods BC at an angle of 24°, the vertical load is calculated, being 11823 N, acting on forward and aft bracket. With this calculated load, the loads on BC and CF can be calculated. Calculations revealed loads as follows: on support rod BC 29068 N, on support rod CF 26555 N and on support rod BE 7662 N.

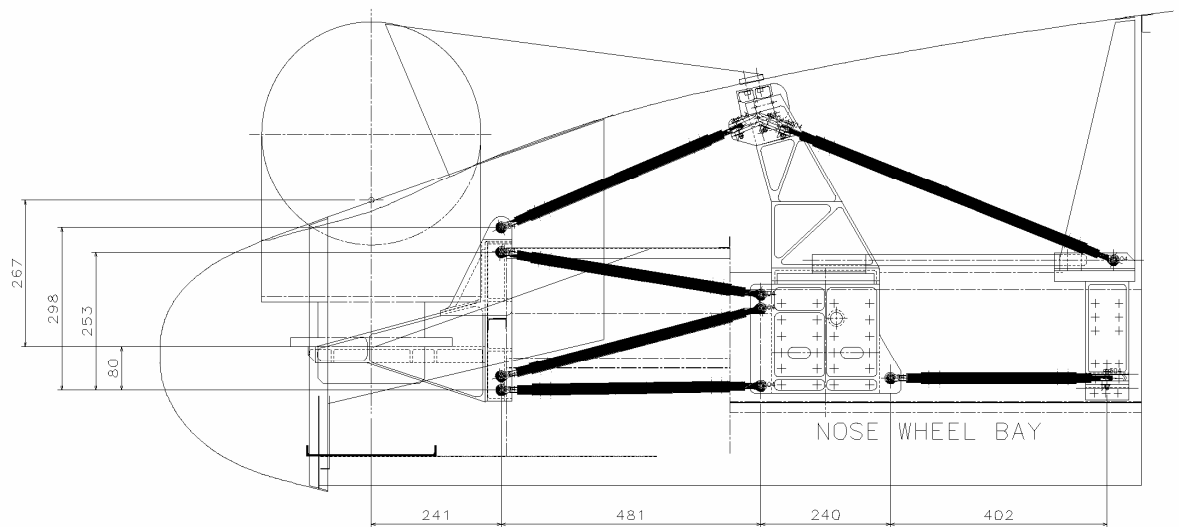
Fig. 4 Drawing of the brackets and frame construction

A single direction curved plate strengthened with ribs, strips along edges, L-profiles and a base plate, was installed behind the camera.

The front fairing side was nearly closing onto the camera, the aft side was mounted onto the nose area skin. The distance between camera and fairing was 5 mm (.20"). The area between camera and nose area was filled up using an aluminum ring-plate which encloses a rubber preformed seal. The air loads on the fairing were calculated at 970 N ultimate load in vertical gust condition, whereas the lateral load resulted in 1385 N ultimate load. Based upon these loads it was calculated that the use of twelve fasteners of type NAS 1133 were enough to withstand the air loads.
